EVALUATION OF KAISER MX19-B AND MX19-C  
ALUMINUM HONEYCOMB LANDING MAT

Army Engineer Waterways Experiment Station  
Vicksburg, Mississippi

MISCELLANEOUS PAPER S-73 II

March 1973

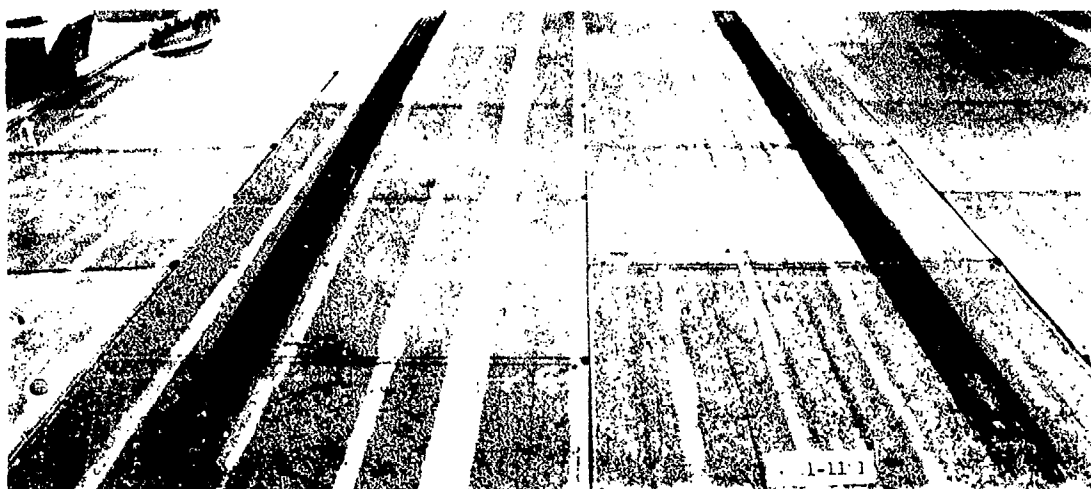
<u>Condition of surface</u>	<u>Length of Skid, ft</u>	<u>Wheel load lb</u>	<u>Average Force, lb</u>	<u>Coefficient of Friction</u>
Dry	18	20,000	6500	0.32
Wet	16	20,000	4500	0.22

Photo 1. Skid marks on dry mat surface

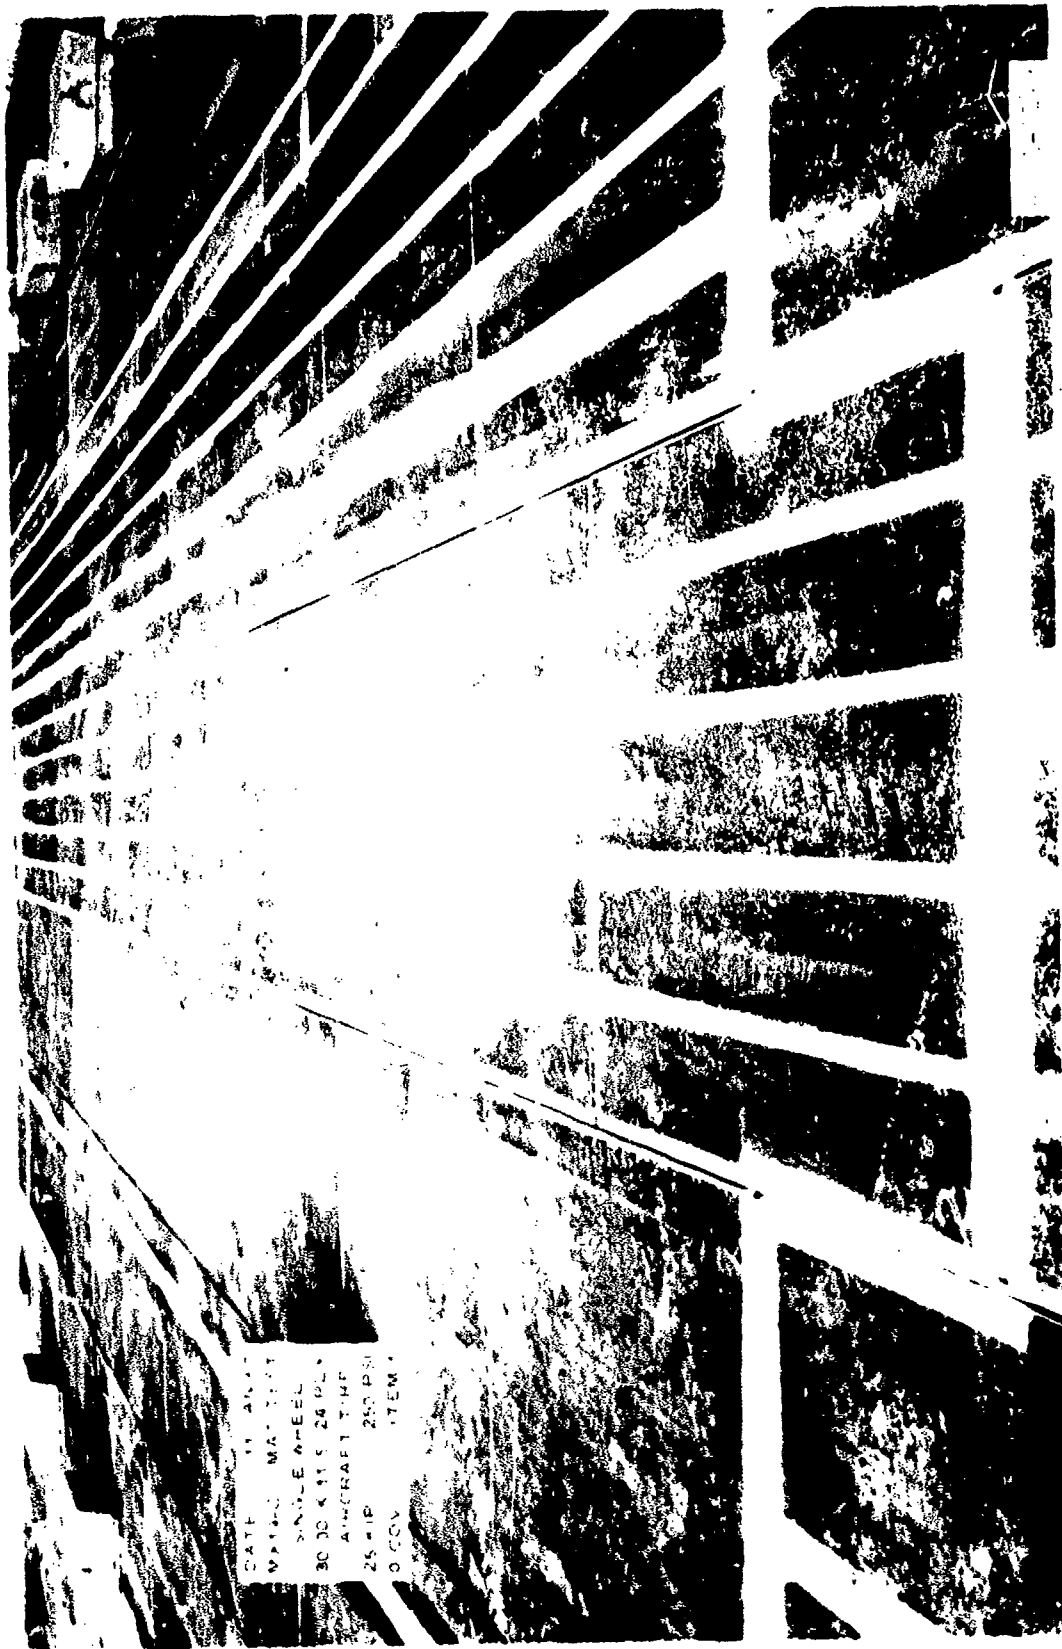
26. Item 1, MX19-C. Prior to traffic, the surface of item 1 (modified female connectors) was generally smooth (photo 3), and the average CBR of the subgrade was 3.4. After 500 coverages, no mat breaks were observed, and the mat was in excellent condition. At 900 coverages, tests of the subgrade indicated that the strength of the upper 12 in. had increased to a CBR of 5.0. Therefore, all panels were removed from the test section, and the subgrade was reprocessed. The strength of the reprocessed subgrade in item 1 averaged 4.1 CBR. Panels were replaced in their original positions, and traffic was resumed.

Photo 5. Item 1 (XX19-C) prior to traffic

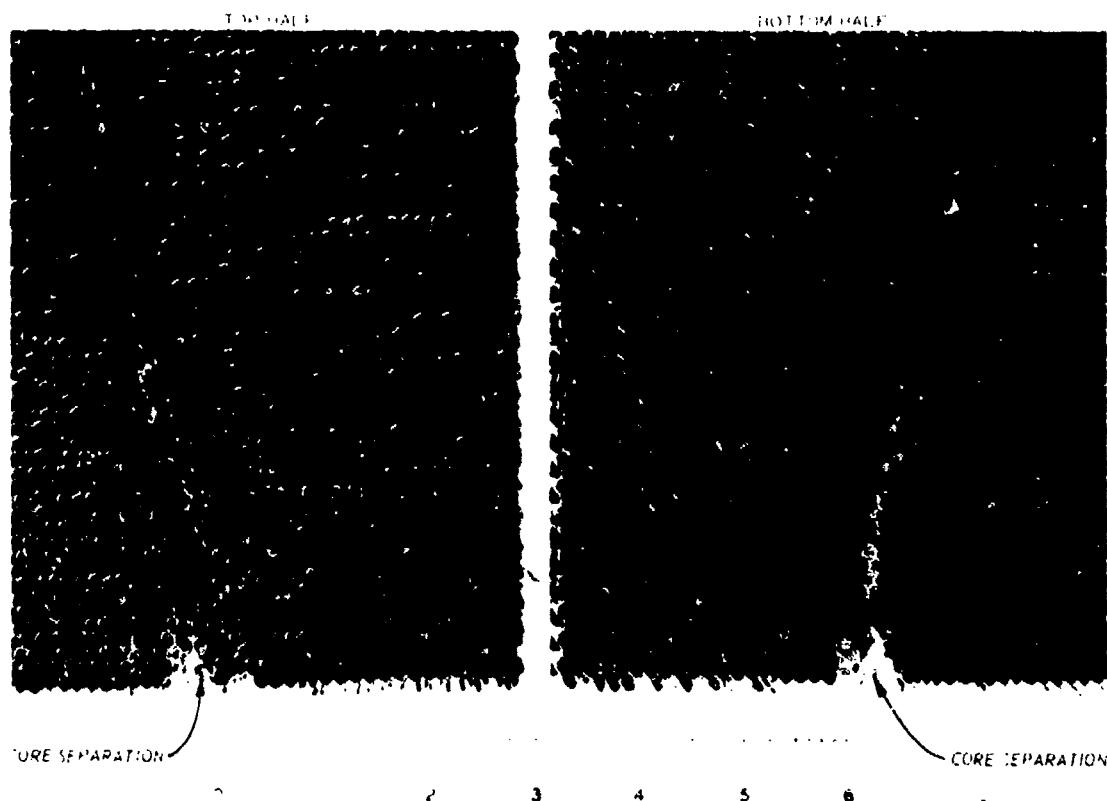
37. Item 1. The first panel failure occurred in the honeycomb core near the center of panel 39 at 1560 coverages. The failed core, dissected for inspection, is shown in photo 4. The second panel failure (panel 11) was caused by the trepanning operation performed during manufacture to check weld penetration. This failure began at 2480 coverages with a small crack 3-1/2 in. long perpendicular to the male connector at the point of trepanning (see photo 5). As traffic continued to 2692 coverages, this crack developed into a 12-in.-long break. This break had also progressed for 2-1/2 in. at the weld along the male connector. At 2756 coverages, panel 11 failed abruptly when the potting sheared along the male connector (photo 6), causing the bottom skin to tear as shown in photo 7.

Photo 4. Separation of core material in failed panel 39 (1560 coverages)

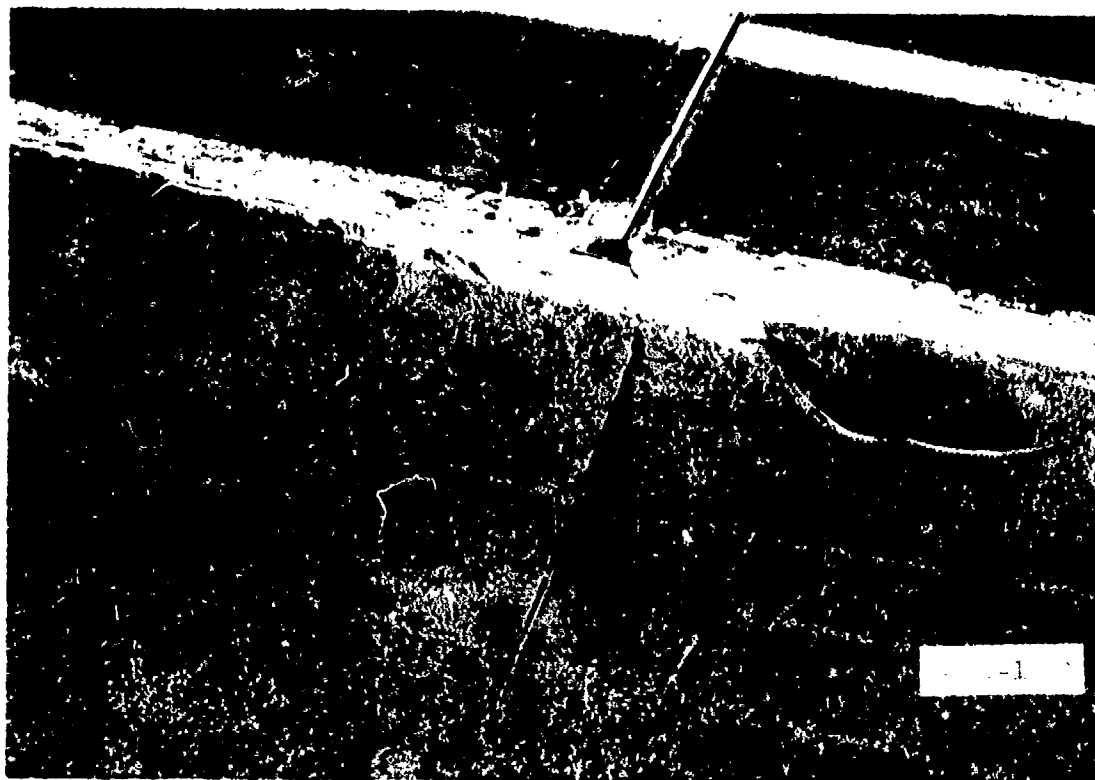
Photo 6. Failure of panel 11 after 2000 coverages

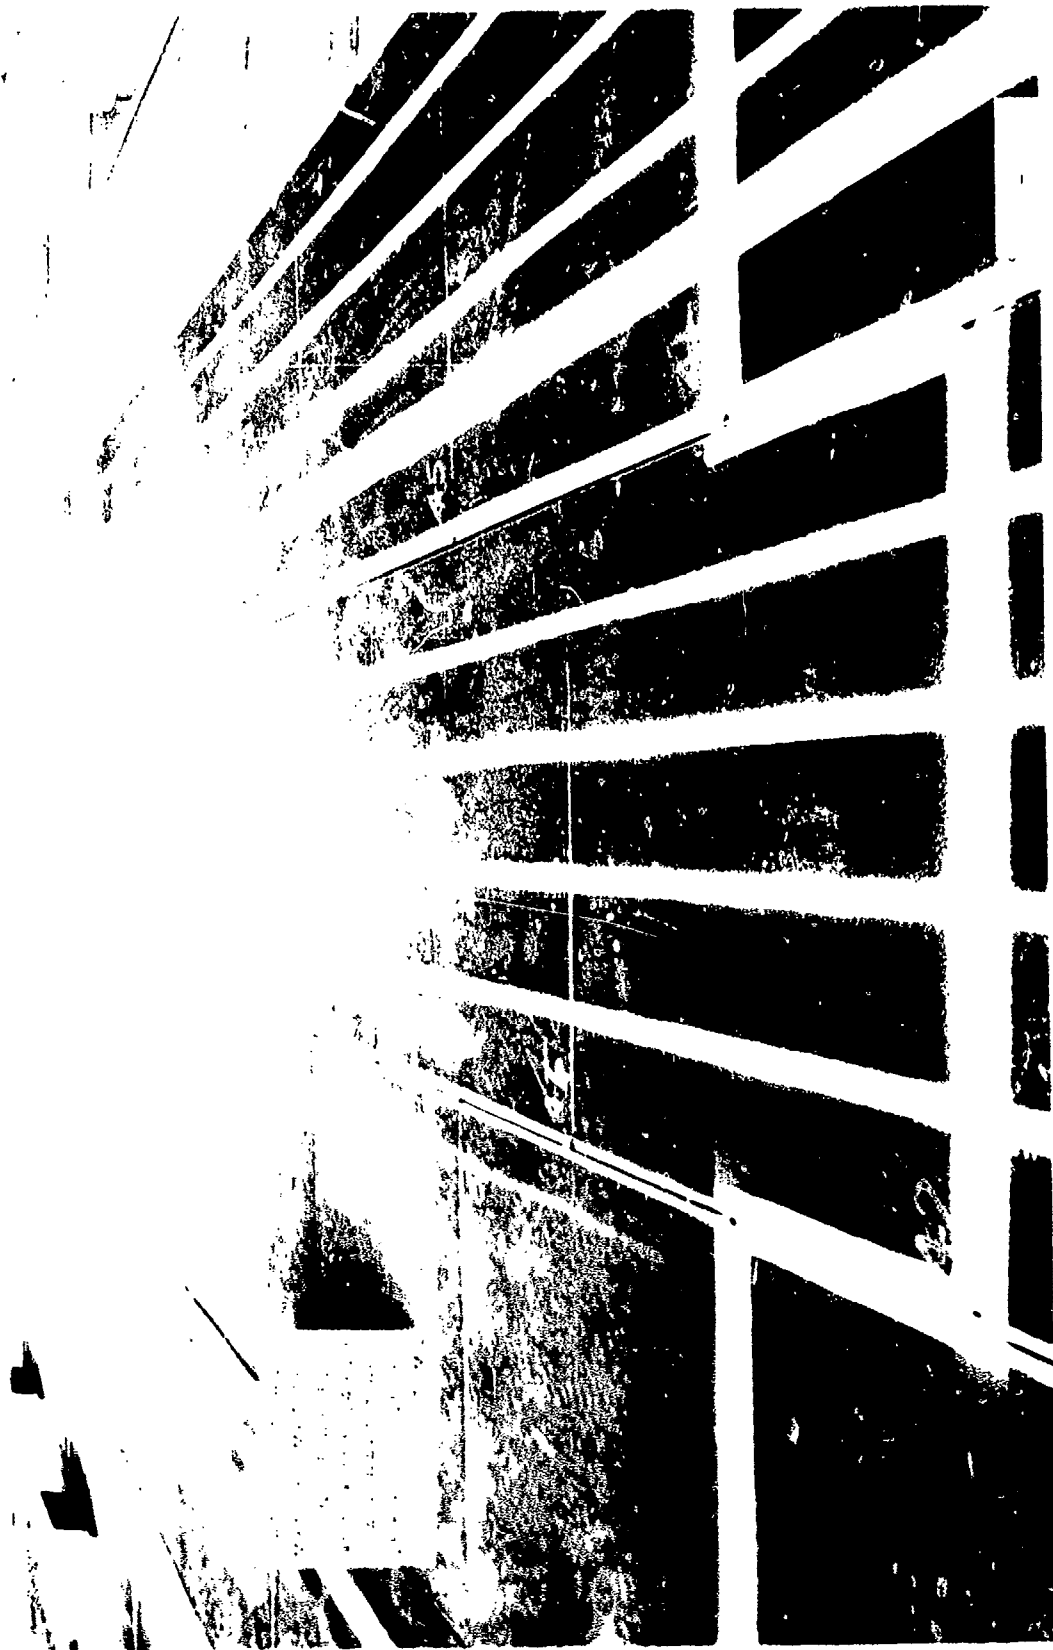
31. Item 2, MX19-B. Prior to the application of traffic, the surface of item 2 (modified female and male connections) was generally smooth (photo 9), and the average CBR of the subgrade was 4.0. After 170 coverages, a narrow 16-1/2-in.-long depression had developed in panel 47, perpendicular to the direction of traffic (photo 10). After ten additional coverages, this depression had increased to 33 in. in length and 11 in. in width. After 190 coverages, panel 47 was considered failed (photo 11).

Fig. 2. Door 2 (0019-2) prior to treatment

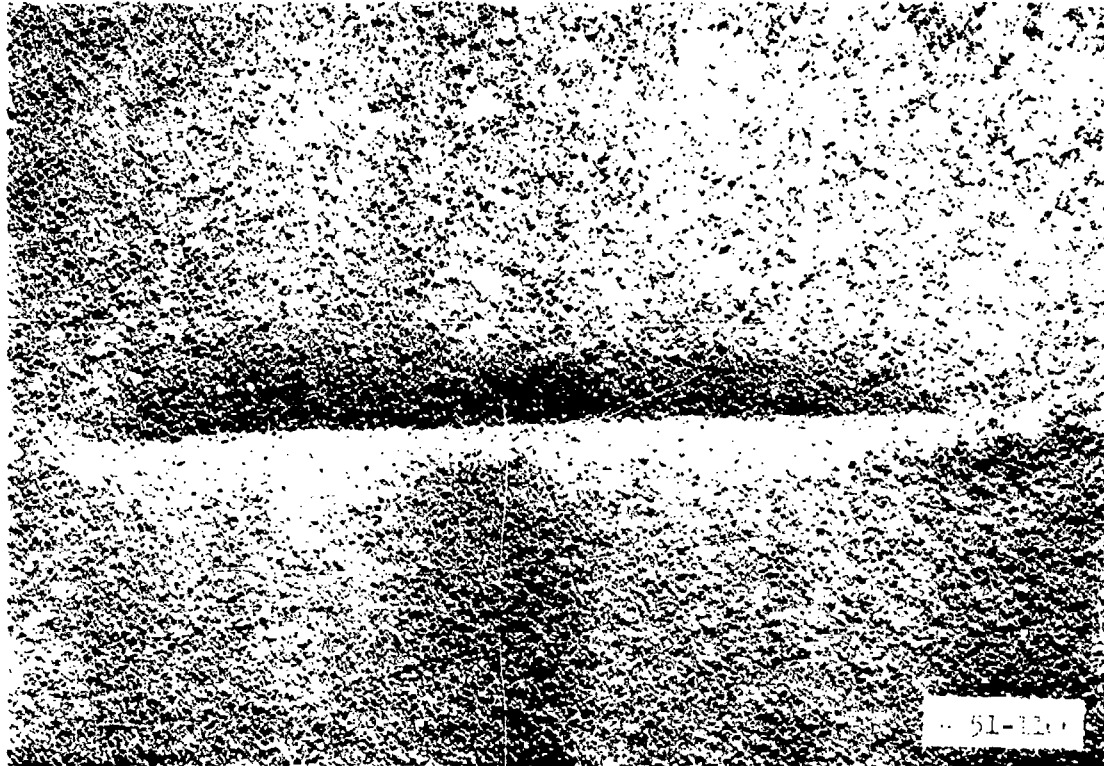
Photo 10. Depression in panel 47 at 170 coverages

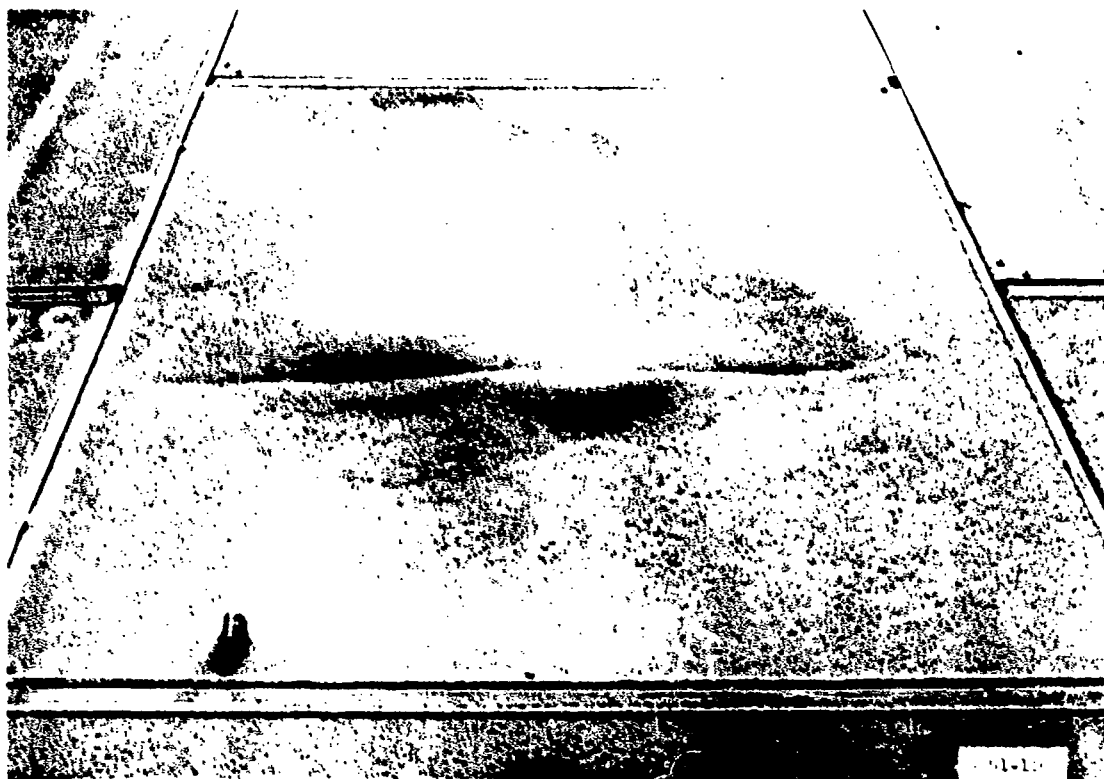
Photo 11. Failure of panel 47 after 190 coverages

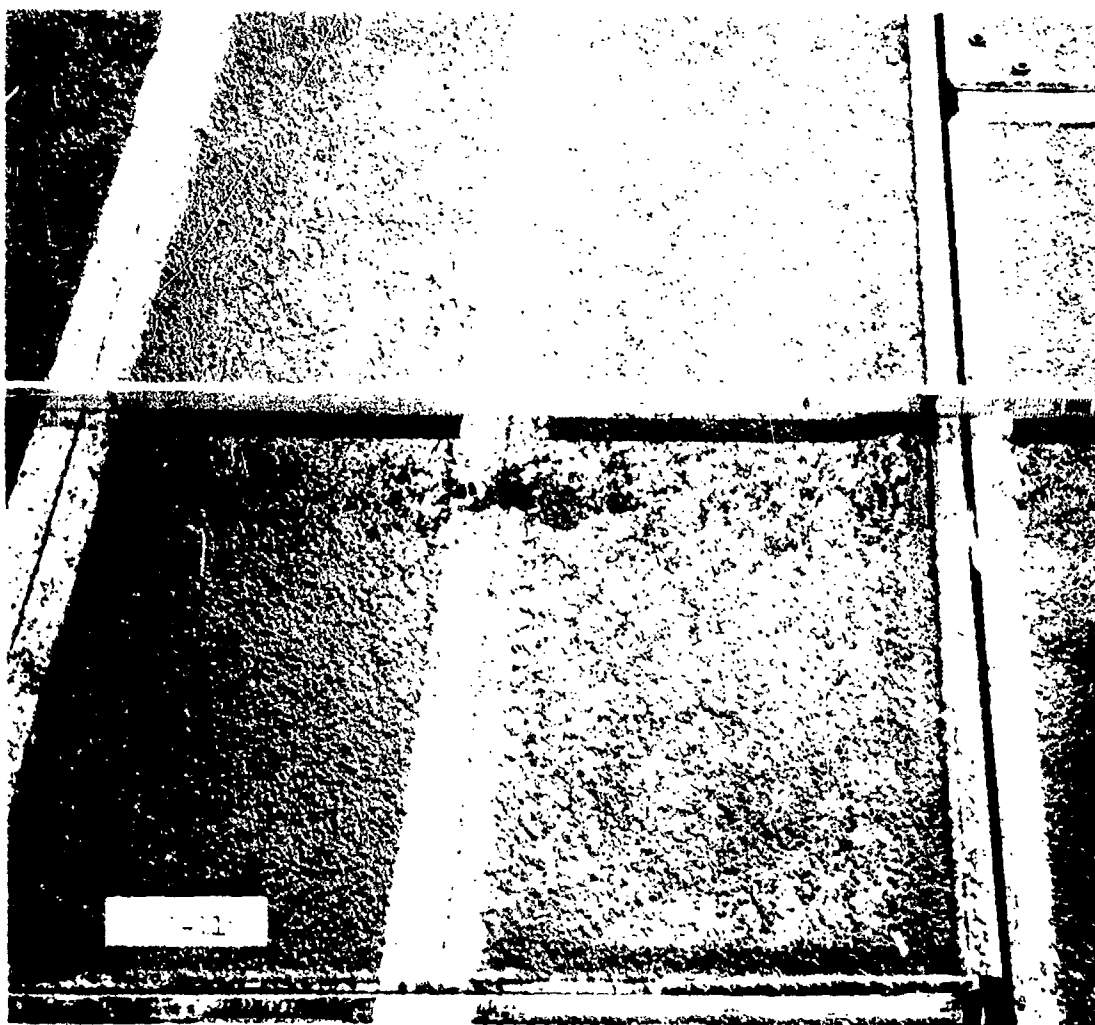
32. At 900 coverages, panel 66 had a 24- by 8-in. depression paralleling the direction of traffic along the female connector (photo 12). Panel 66 was considered failed and was removed from the test section and replaced with a new panel. Soil tests under panel 66 revealed that the CBR of the top 12 in. of the subgrade had increased to 6.0. Therefore, all panels were removed from the test section, and the subgrade was reprocessed. The strength of the reprocessed subgrade in item 2 averaged 3.9 CBR. Each panel was replaced in its original position, and traffic was resumed.

Photo 1. Failure of panel 66 after 900 coverages

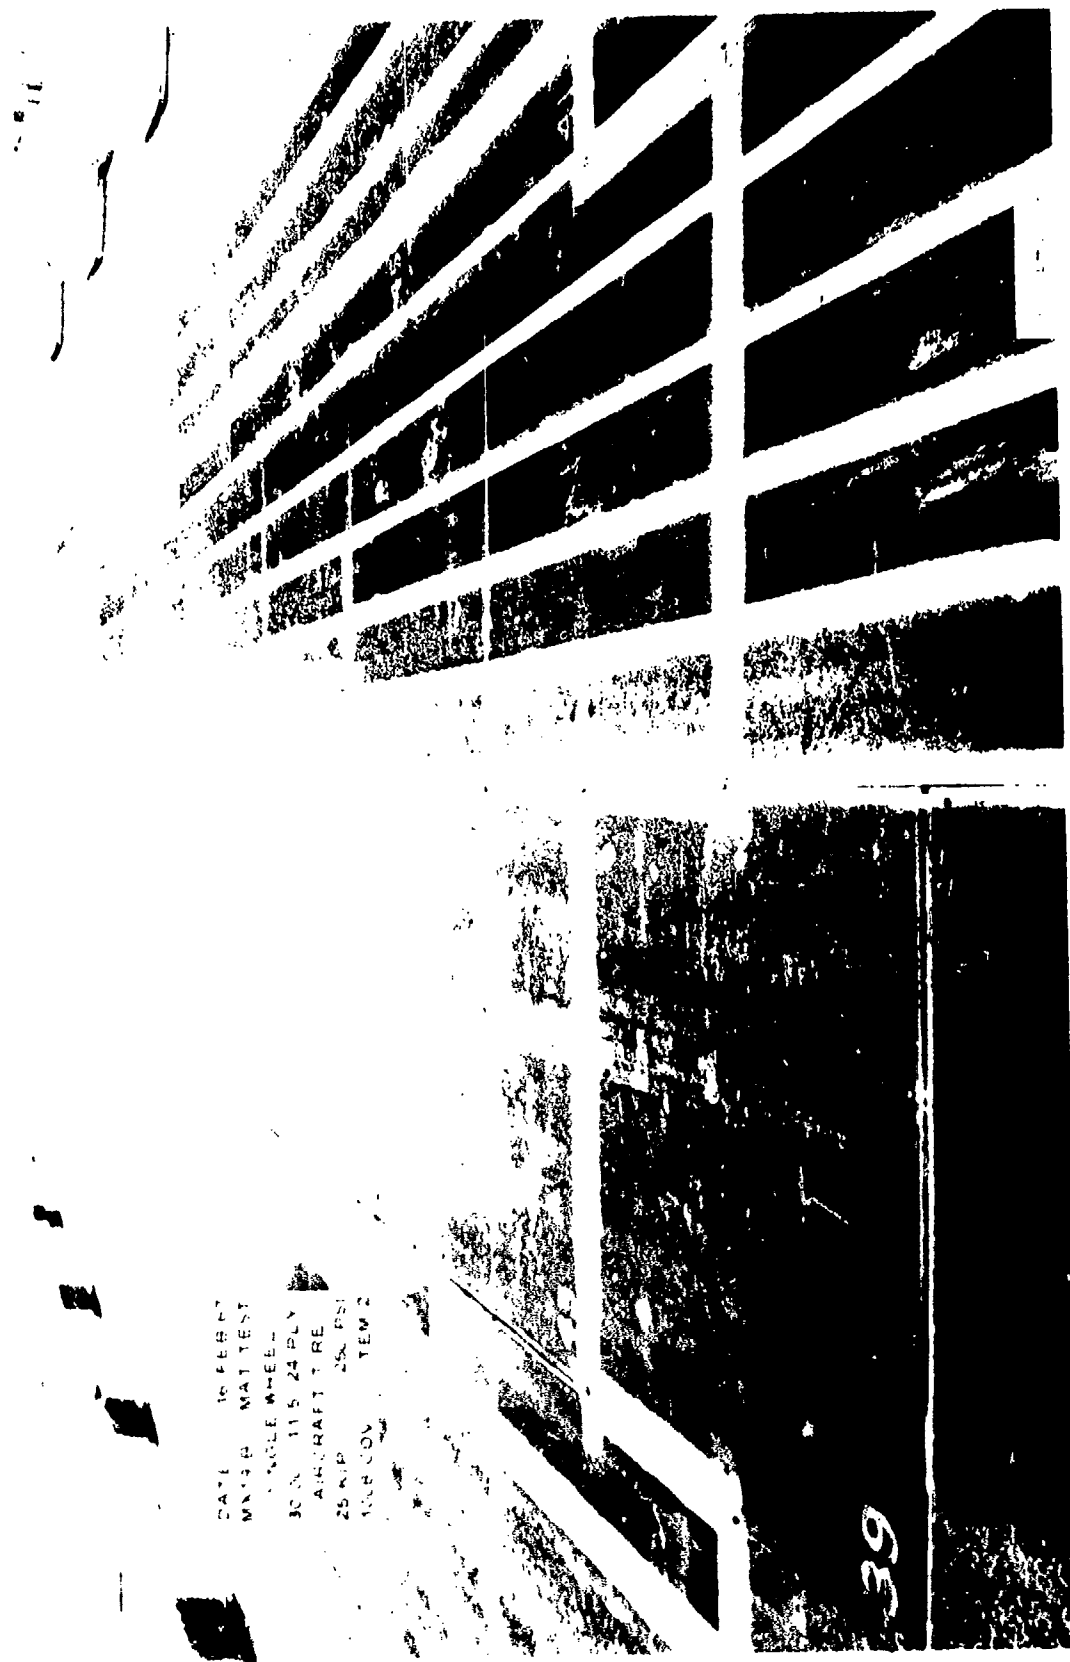
34. At this point, soil tests were performed under panels 70 and 78 (table 1). The general condition of item 2, other than panels 43 and 78, at 1008 coverages was good (photo 14). The maximum permanent deformation measured was 0.4 in. (plate 7), which occurred at 500 coverages, and the maximum static deflection was 0.7 in., measured at the joint of two panels at 1008 coverages (plate 5).

Photo 14. Item 2 after 1008 coverages

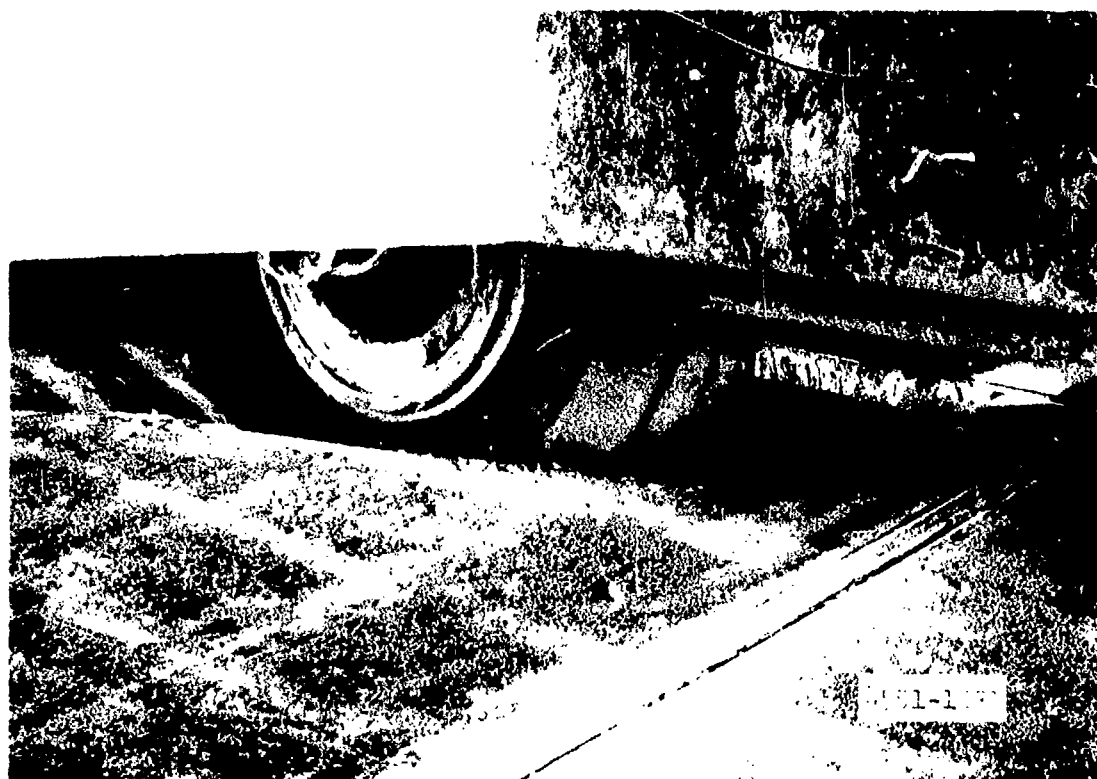
35. Since traffic was continued on the test section after item 2 (MX19-B mat) had failed at 1008 coverages, further observations of the performance of item 2 were possible. The break in panel 43, which had developed after 940 coverages at the point of trepanning on the male connector (see paragraph 33), lengthened as follows:

Photo 15. Collapse of panel 43 at 1386 coverages

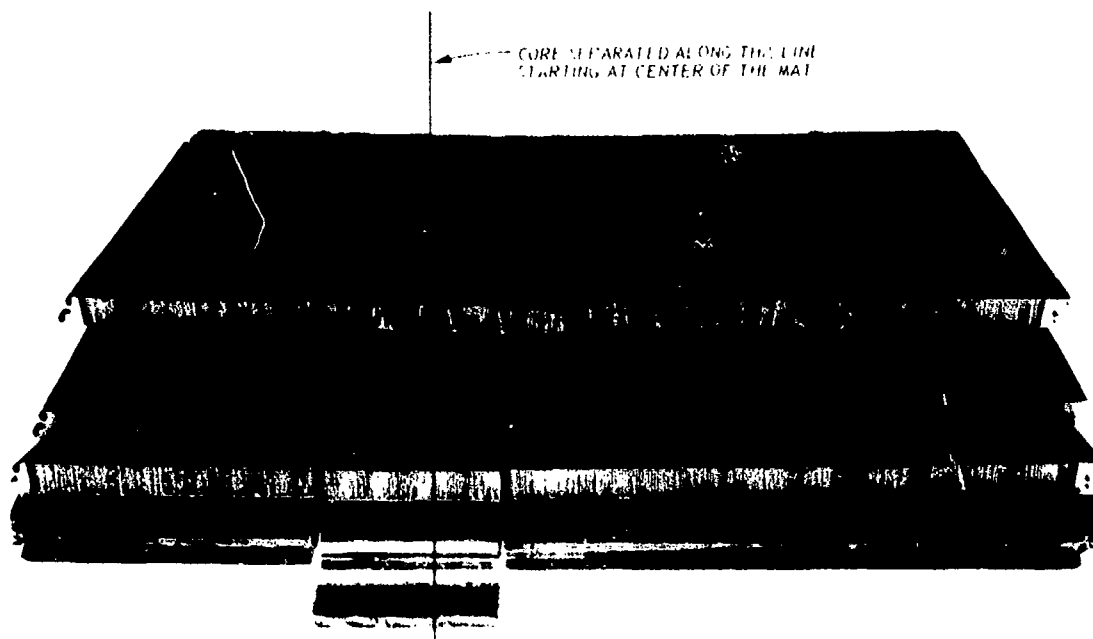
38. Item 2. The first panel failure occurred in the honeycomb core near the center of panel 47 at 190 coverages. This failure began as a small depression followed by a greater depression and separation of skin and core materials. Photo 17 shows the panel after being cut and dissected for an inspection of the core failure. The second panel failure (panel 66) also occurred as a depression in the core material approximately 24 in. long in a longitudinal direction and 8 in. wide in

Photo 17. Panel 47, dissected, showing core failure at 190 coverages

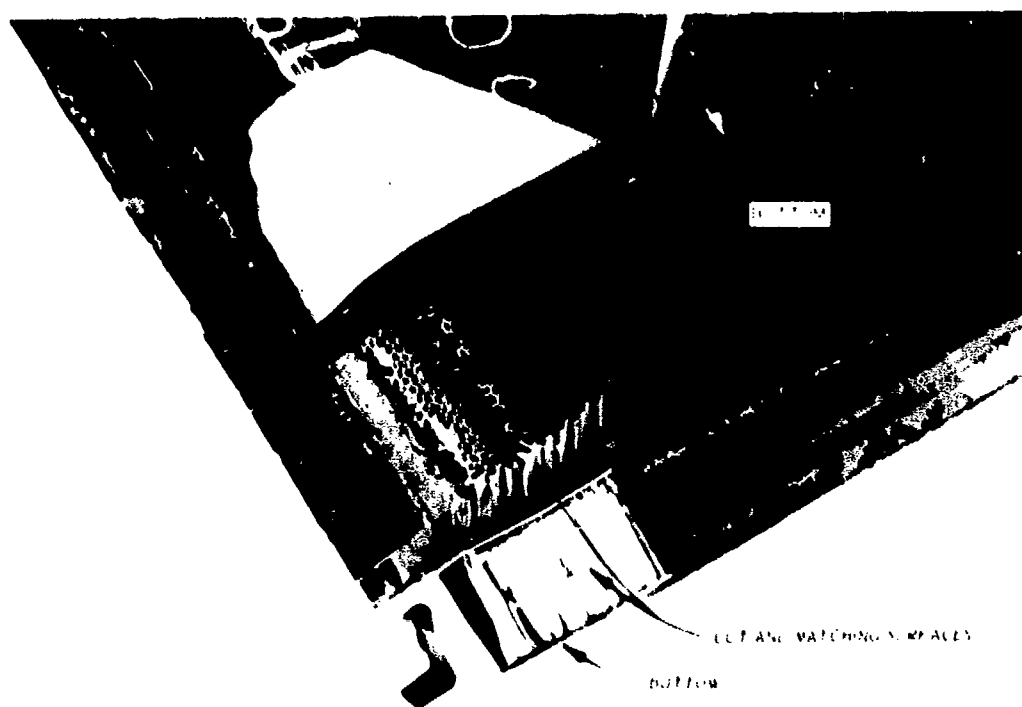
an area along the female connector (900 coverages). Photo 18 is a closeup view of panel 66, showing details of the failure. The maximum deformation measured in this panel was 0.15 in. After 948 coverages, panel 67 revealed signs of distress with a small crack at the center of the panel beginning at the male connector and progressing transversely, identical with the failure of panel 11 described in paragraphs 28 and 37. Panel 67 was removed for analysis. Failure was considered imminent, and this panel was replaced with a new panel.

Photo 18. Panel 66, dissected, showing core failure at 900 coverages

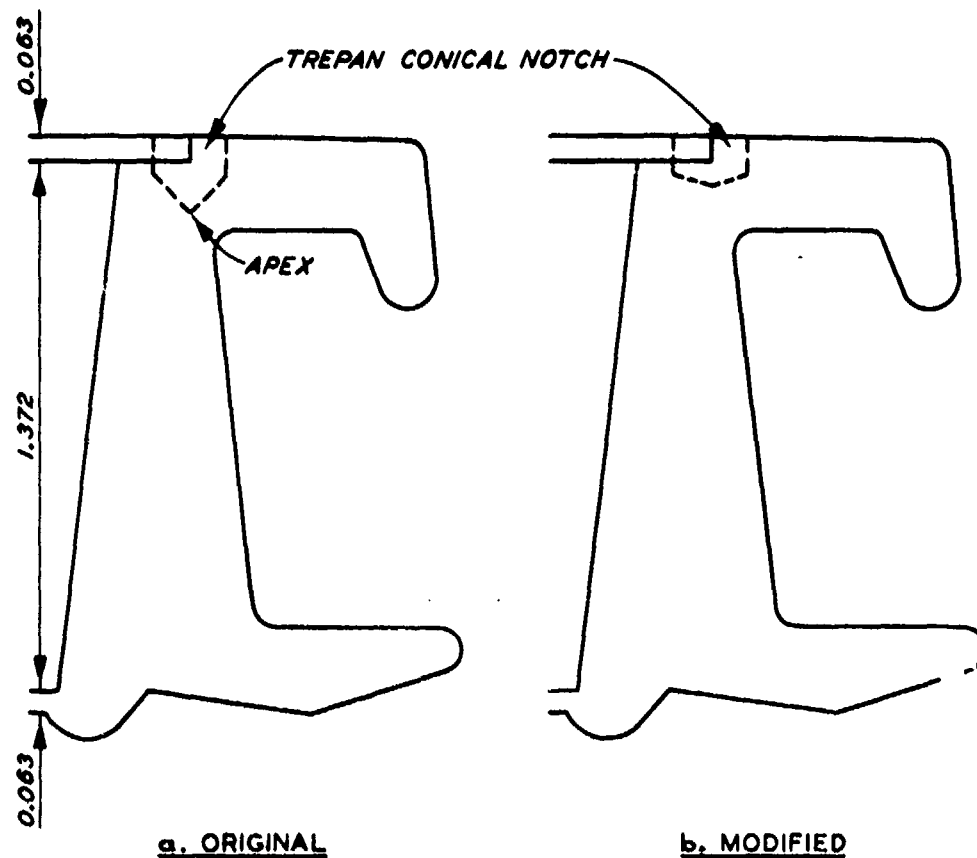
TREPAN CONICAL INSPECTION NOTCH

40. An analysis of the failure of panels 11, 43, and 67 revealed that the trepanning operation and the method and location of the operation had contributed to premature failure of these panels. The trepanning operation was located at the center of the connectors and was at a point of maximum stress concentration on the male and female connectors as adjacent panels transferred the load at these points. Weld inspections at the quarter point or at any other point, except where these maximum stresses were concentrated, would probably have prevented these failures. Also, the inspection notch (hole) should have been changed to a flat-bottom hole to ensure complete refilling of the hole with weld. These two types of weld inspection holes are shown in plate 8.

NOTE: WHEN THE TREPAN CONICAL NOTCH WAS REWELDED IN THE ORIGINAL, A VOID WAS LEFT AT THE APEX.

Premature failure of some of the panels, resulting from breaks along the sheet-to-male-connector welds, indicated that the location of treganning should be shifted from the center of connectors and that the shape of the notch formed during the procedure should be altered to permit complete refilling of the hole with weld.
